### A Research Bulletin

Prepared by Organizational Results Missouri Department of Transportation

#### June 2009

# Roller Compacted Concrete Project – Lessons Learned

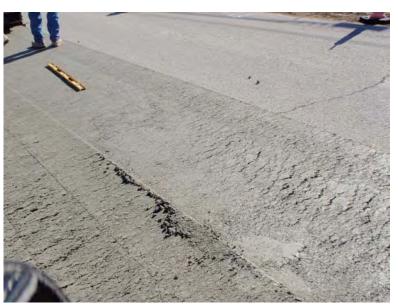
Through the leadership of Central District Engineer Roger Schwartze and Glenn Robertson of Emery Sapp & Sons, RCC specialists were brought to Missouri to test this innovative overlay option. A.G. Peltz Company placed a RCC overlay on Ponderosa Road on October 29-30, 2008 with the help of local contractor Emery Sapp & Sons. The test overlay, in Boone County just south of Columbia, was placed on two, 10.5-foot lanes measuring approximately 2,000 feet in length. Unlike conventional concrete overlays, local traffic was allowed on the overlay within 24 hours of placement.

MoDOT did not achieve the results with RCC that were anticipated. The pavement, which is less than six months old, is showing some deterioration in the form of surface raveling, and an overlay is being considered. However, MoDOT material engineers do not believe that the RCC paving product on Ponderosa Road is representative of typical end products.

MoDOT is still interested in pursuing RCC techniques and has been working to determine what went wrong with the project. MoDOT staff believes that the issues come down to three categories: mix optimization, surface curing, and proper compaction and placement.

Mix Optimization: The aggregates used in the Ponderosa RCC project consisted of gap graded crushed limestone and manufactured sand. RCC mix is very dry and care should be given to having a uniform graded course aggregate. The use of natural sand also would have provided a more workable mix.

Surface Curing: The Ponderosa pavement was not cured and no curing compound was applied. Due to the dry nature of the mix, any moisture loss will inhibit full hydration. Another problem occurred because the trucks delivering the mix were not tarped, which most likely compounded the issue of moisture loss. RCC must be near the optimal water content in order to be compacted properly.

**Proper Compaction and Placement:** It is obvious from the density testing and permeability tests, that the payement did not get fully compacted. It is unknown at this time if the lack of compaction was due to equipment malfunction or mixture design or a combination of both. The Ponderosa project was delayed a day due to problems with the paying machine, it is possible the equipment was not performing adequately.
